Restoration of al-Ashrafiyya Mosque and Madrasa Ta'izz - Yemen

2008-2014

In the present analysis, some of the most exemplary works that the Istituto carried out are depicted.

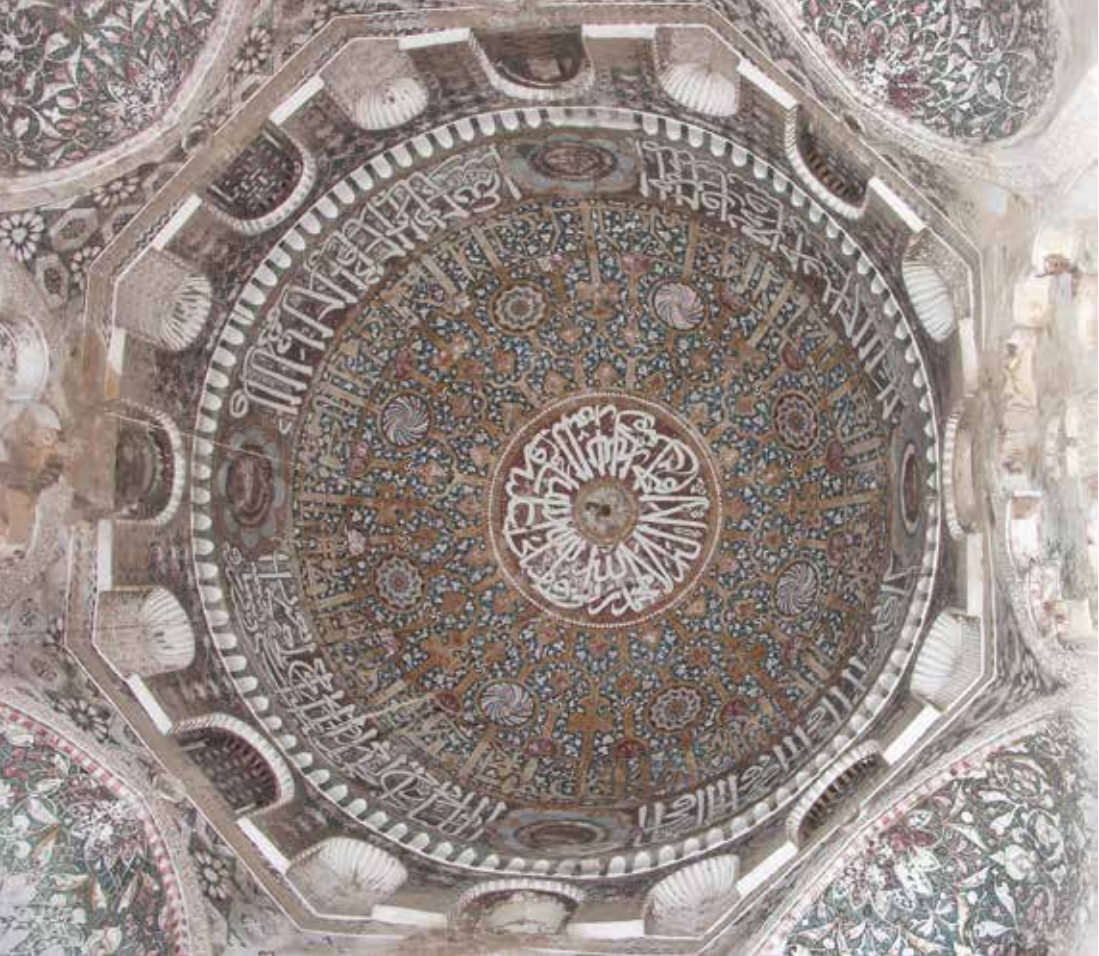
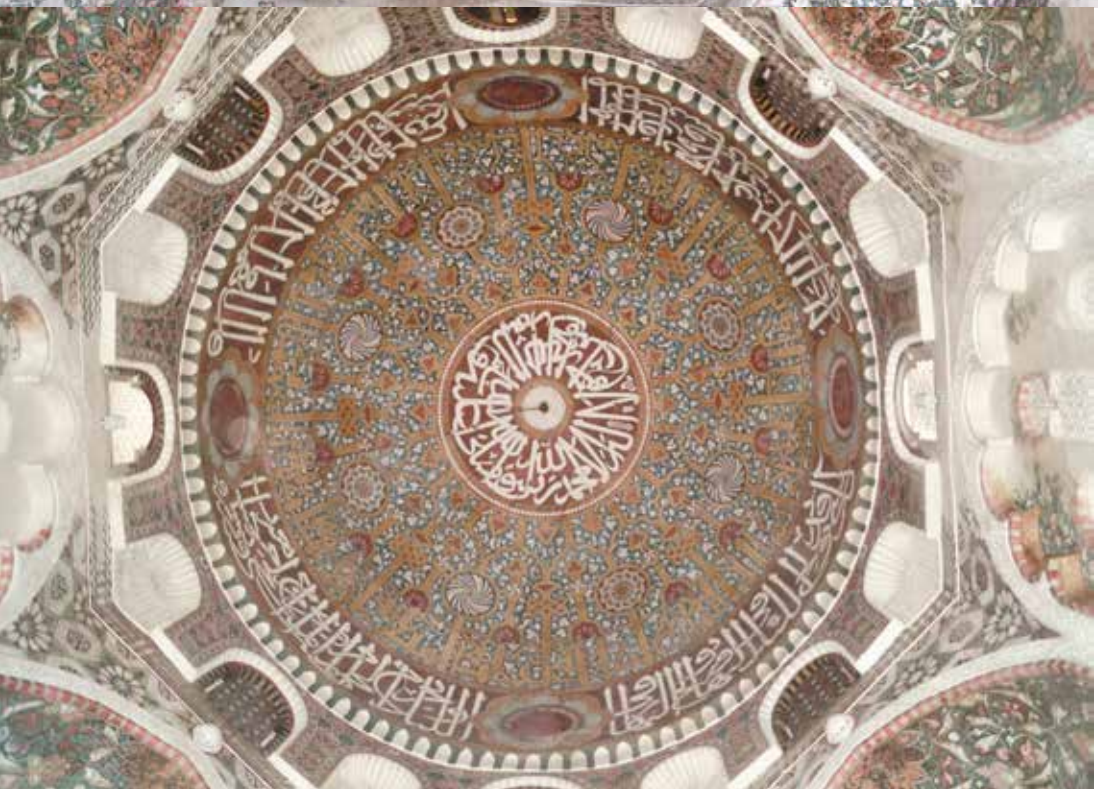
The central dome (left), the northern wall (above) and the eastern wall (under) before and after the restoration

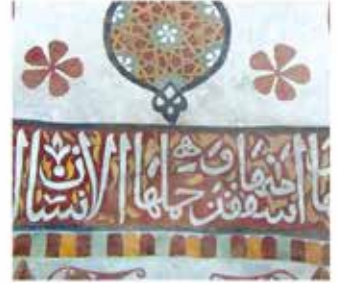
SECTOR A

dome

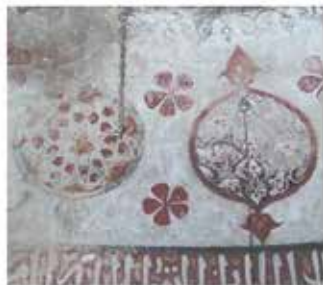
SECTOR D

before

dome

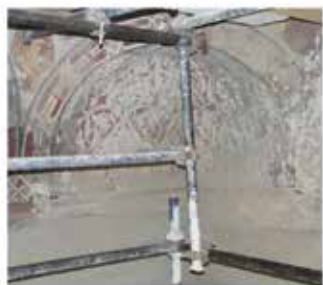
tambour

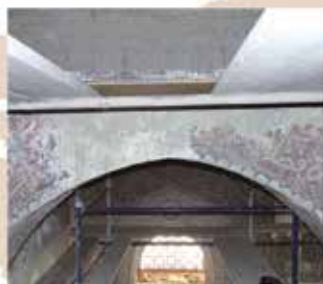
walls

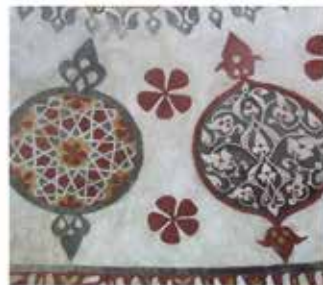
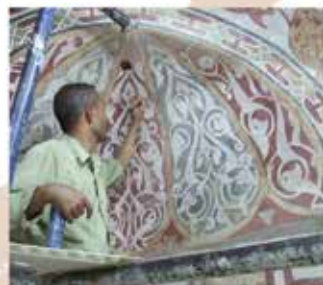
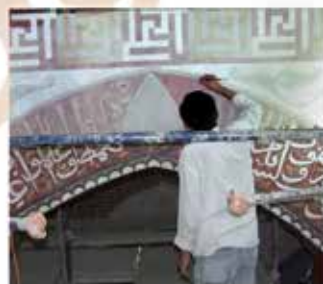
work phases

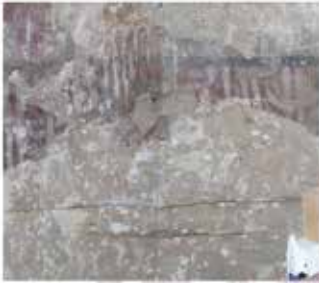
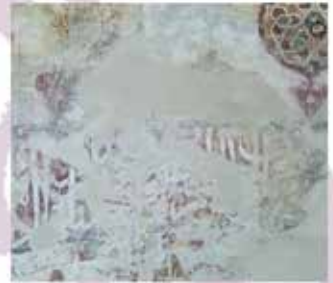
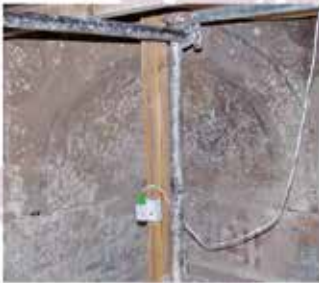
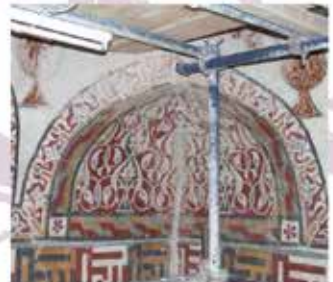
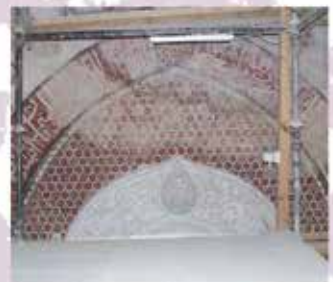
SECTOR H
work in progress

dome

tambour

walls

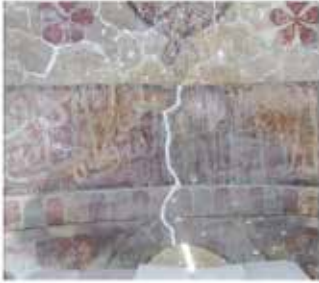
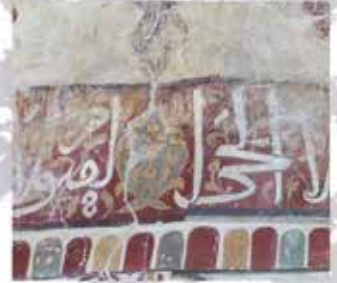
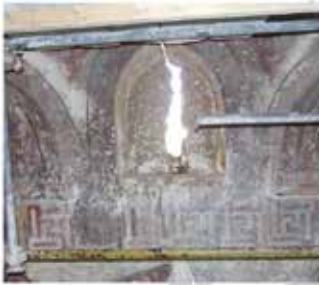
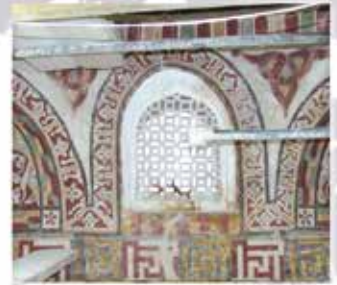
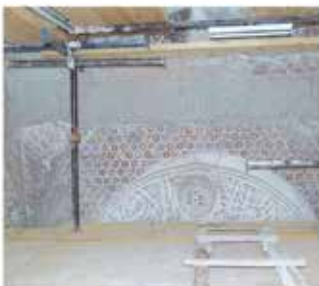
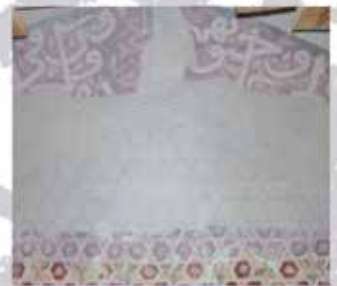
SECTOR I
work in progress

dome

tambour

walls

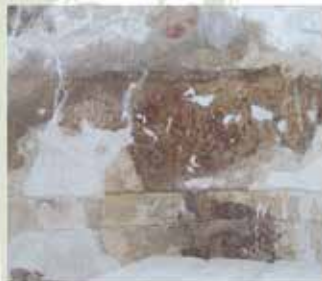
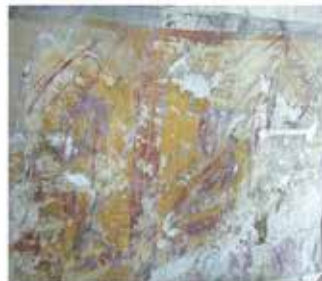
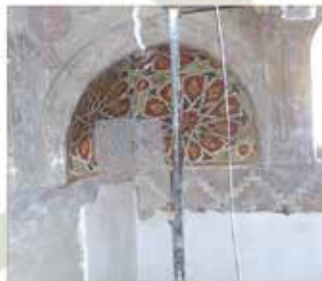
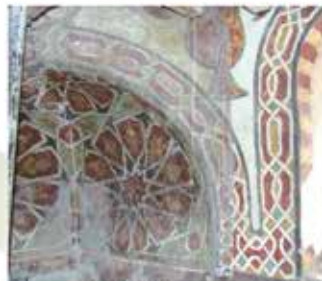
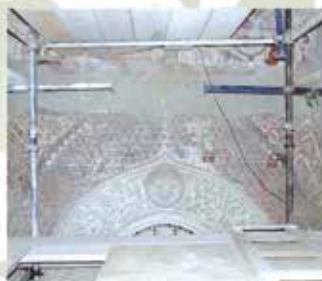
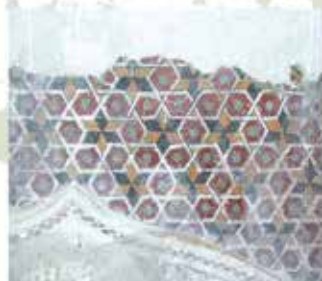
dome

tambour

walls

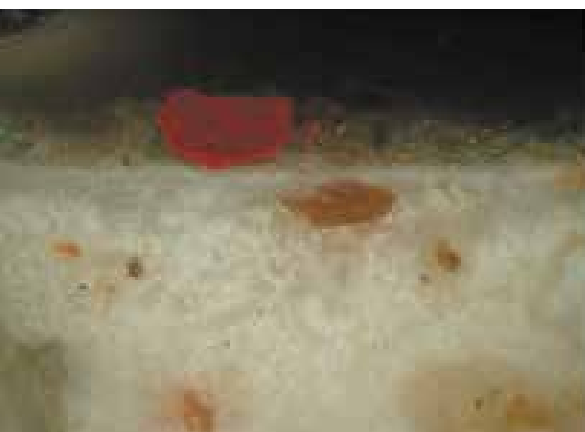
Sample T-2: microphotography in reflected white light (clear section, 500X)

In the two minor domes, the supporting plaster, on which the decoration had been realized, is in *qadad*. This is a mixture of lime and coarse-grained inert (gravel and volcanic limestone) which, during the implementation, is repeatedly wet and beaten with an edged-stone; on the first layer a second one is applied with a finer granulometry and is again beaten until the complete interpenetration of the mixture. The whole is further refined and smoothed with a flat stone in order to make the surface shiny.

On the wet *qadad*, a mural decoration had been painted both with pure pigments diluted in water or melted with limewater. This technique can be included in the fresco technique, which is likely a legacy of the ancient

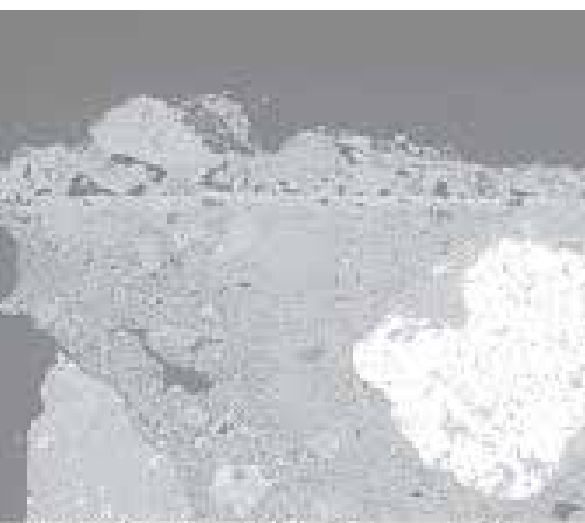
Sample T-2: microphotography with the ESEM (400X)

Sample T-2: EDS spectrum

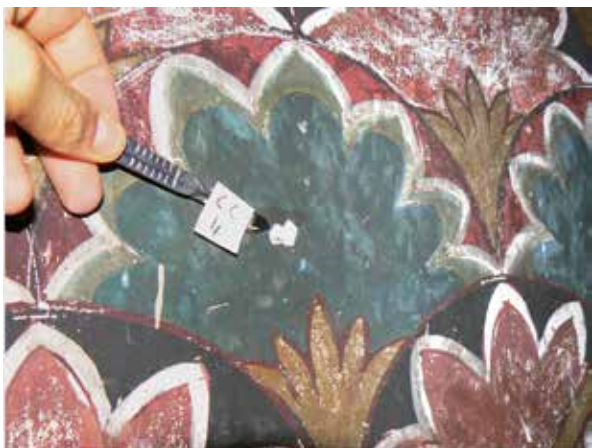
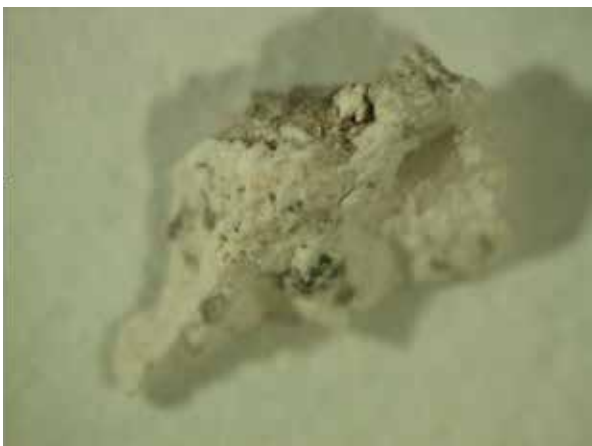
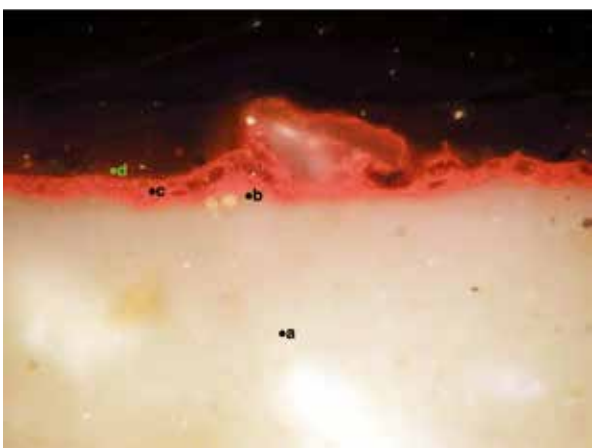
Main dome. Graphic survey of the mechanical dry cleaning (above) and cleaning with organic solvents (under)

The cleaning phase went through different methods, depending on the situation: use of dry with w-shab sponges, fiberglass pens and scalpels, or a fat emulsion throughout on the deposits of oily substances due to the smokes of the oil lamps.

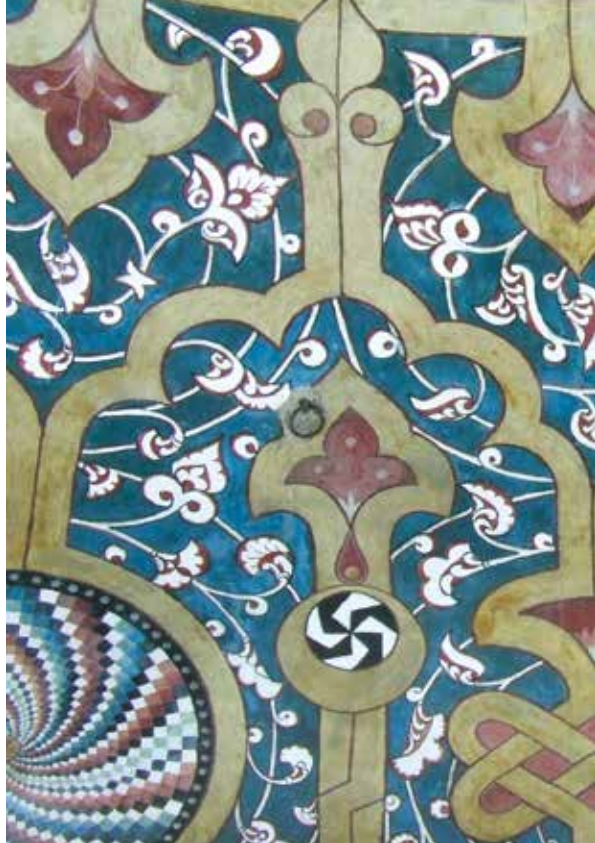
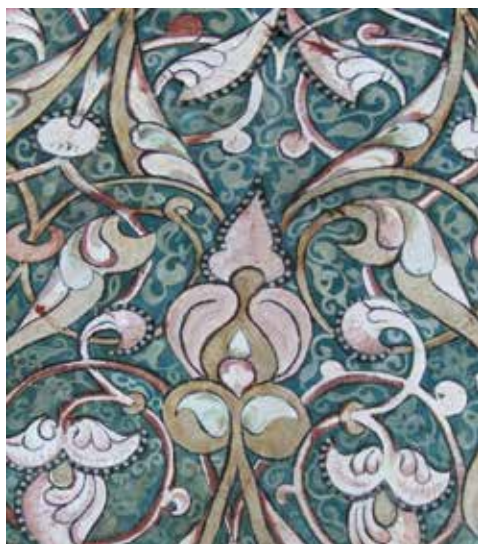
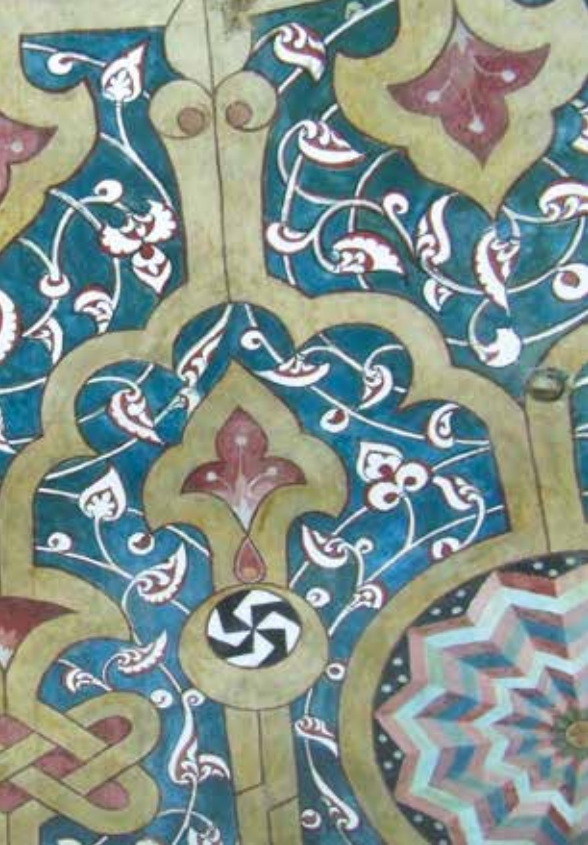
Main dome, particular of the vault decoration on the east side (above), particular of the north-west niche decoration (under) and particular of the five-lobed window decoration (right)

Thanks to the removal of the lime layer inside the big niches of the main dome, the whole decorative setting was brought back to light and under them surfaced five-lobed palms on a black background and portions of Quranic inscriptions.

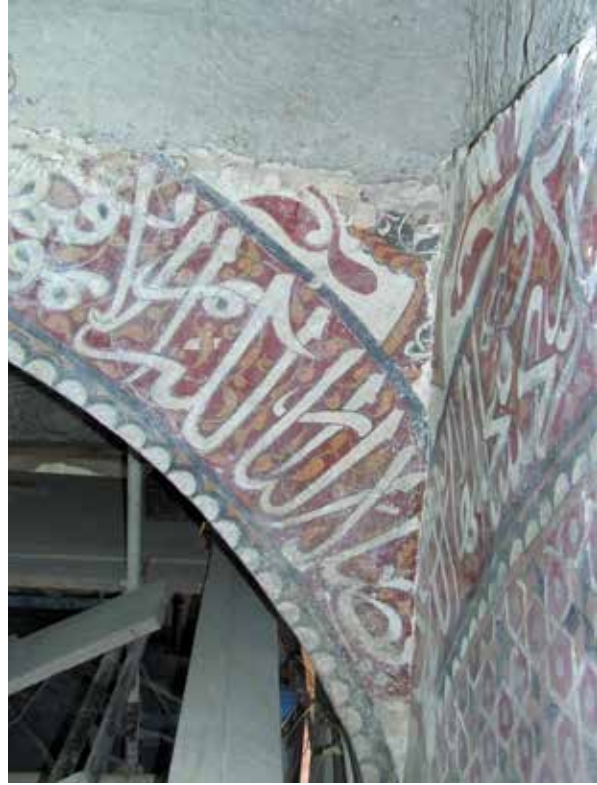
Minor dome, particular of a large lacu-na in the south-east coin (above) and overview of the east sector (under)

Minor dome, hatching, retouching and simplification of a floral pattern (above)

In accordance with the historical authenticity, the restoration was re-alized through the hatching, a re-touching technique (*rigatino*) that differs from the original painted backgrounds; a touch up re-composi-tion imperceptible from the distance, but identifiable close up. The metho-dology used was to transfer the pre-paratory drawings (studied from the remaining models) on to the plaster with the paper pouncing patterns.

cal strokes (in harmony with the original corresponding colors) in order to reach the most unity and continuity of the surrounding decoration.

In order to further distinguish the reconstructions, the details were simplified and, in some parts, not defined. The red and yellow floral patterns, on the white background of the pendentives, and other similar elements, were executed through hatching, however not in a vertical direction, but by setting the colored dashes in concentric expansion, according to the graphic pace of each shape.

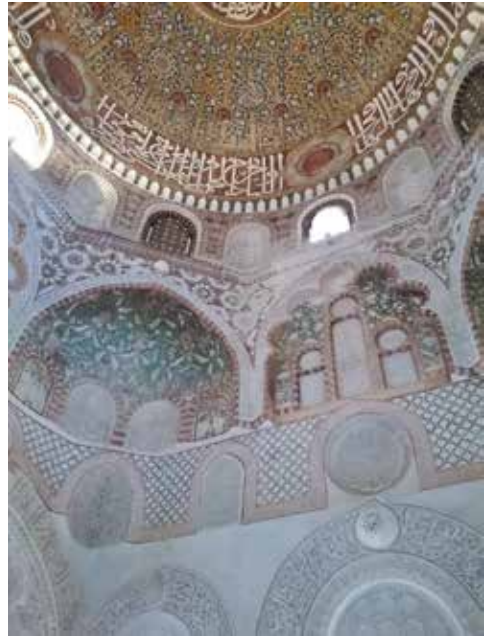
The main dome, view of south eastern elevations (above) and particular of the architrave and of the five-lobed window (under)

Two measures were adopted: the first was the rebuilding of the missing stucco frames of the arched windows, and the second involved the painting of the octagonal architrave, which marks the string-course and supports the drum above, with rhomboidal motifs to give the impression of illusory jagged reliefs.

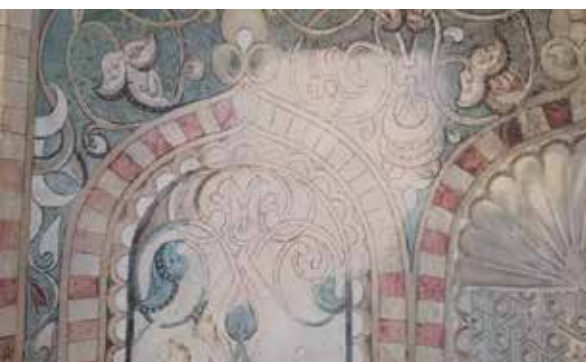
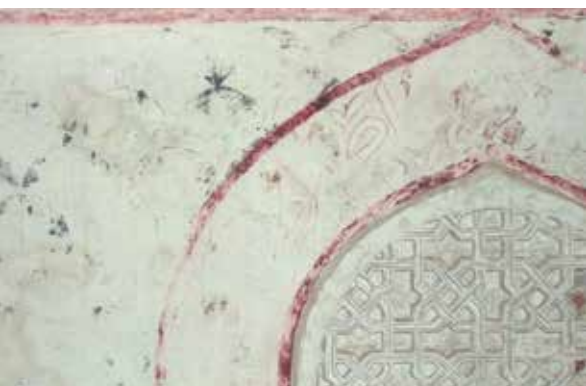
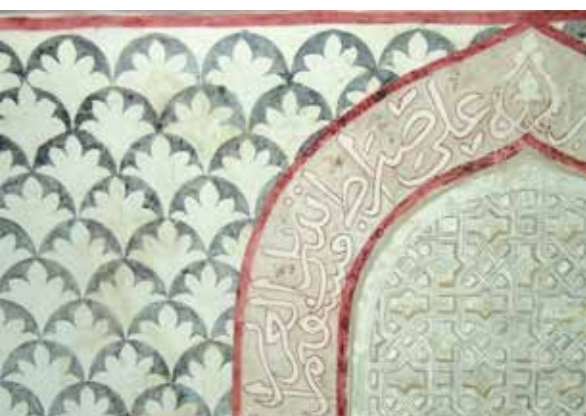
The main dome, north-west niche, reconstruction of the preparatory drawing (above); particular of the strip surrounding the Mihrab before and after the integration (under)

The same principle was adopted for the two medium-size lacunas located on the large niches in the corner of the northern wall, inside of which the profile of the floral patterns were traced to define the idea of the preparatory drawing.

Hence, it was decided to recuperate both, the reading of the verses and the harmonious balance between the two registers, reinstating on the surface the outlines of the Quranic inscriptions and redesigning the palmettes with watercolors, so as to maintain a muffled tone, distinct from the original.

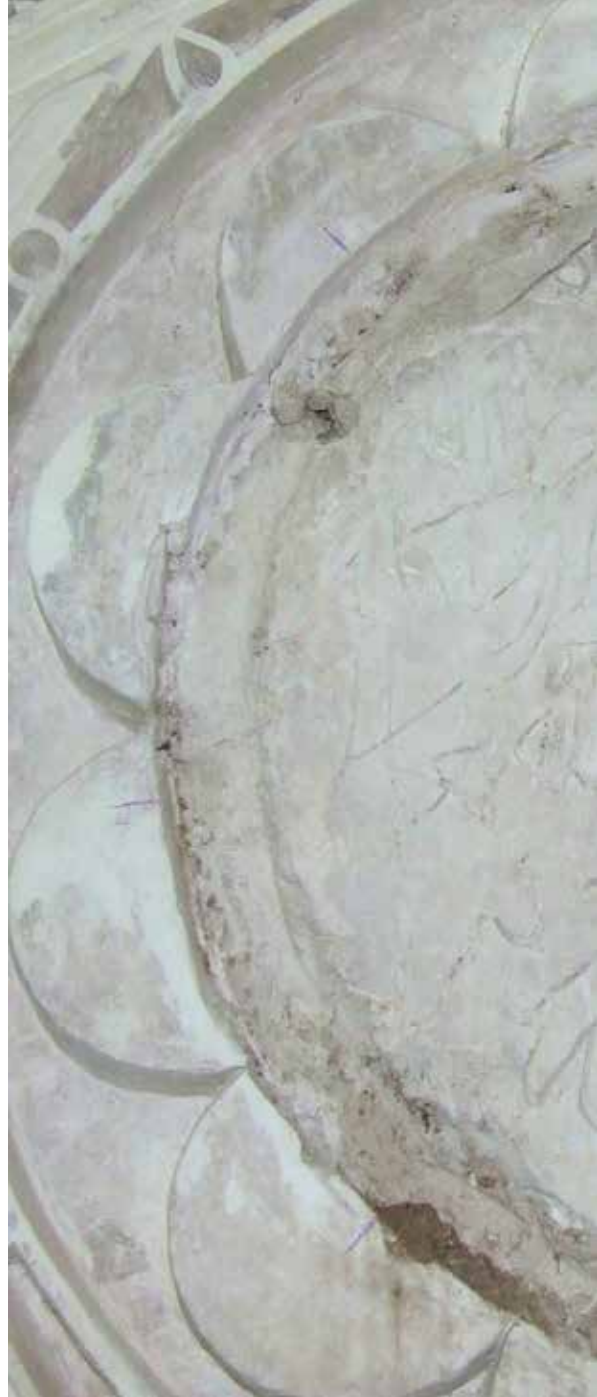
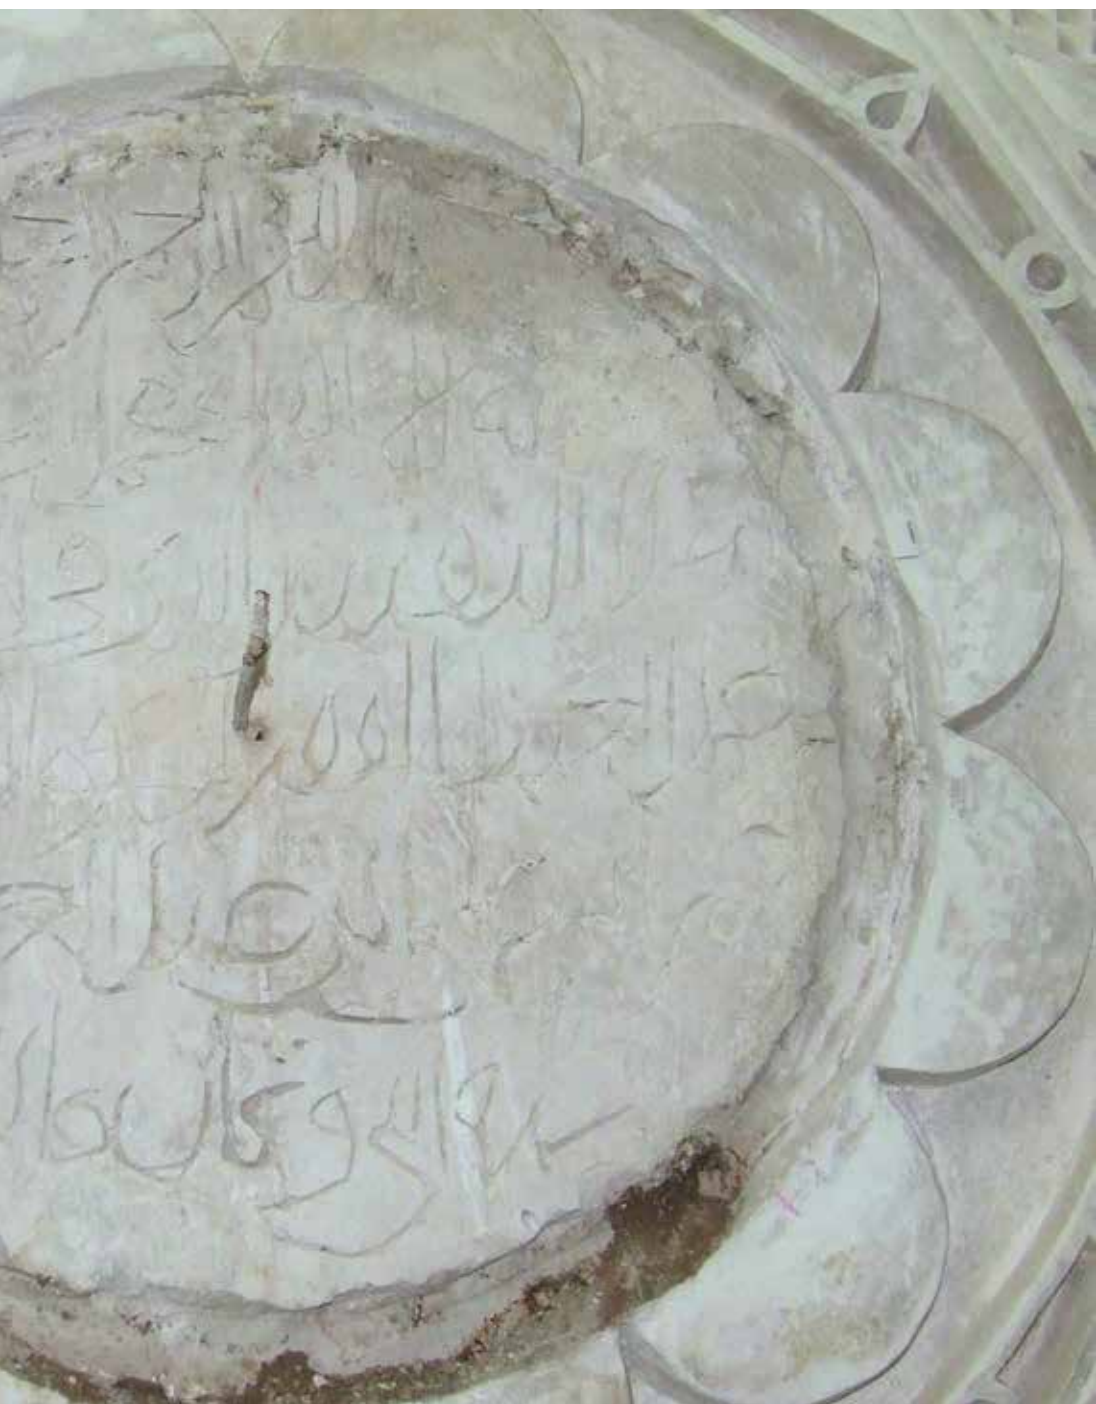
*The main dome, carved dedication
with date and signature*

The discovery of a carved dedication with the decorator signature and the date of realization, hidden under a pierced gypsum hemisphere that was temporarily removed during the work, is of great importance.

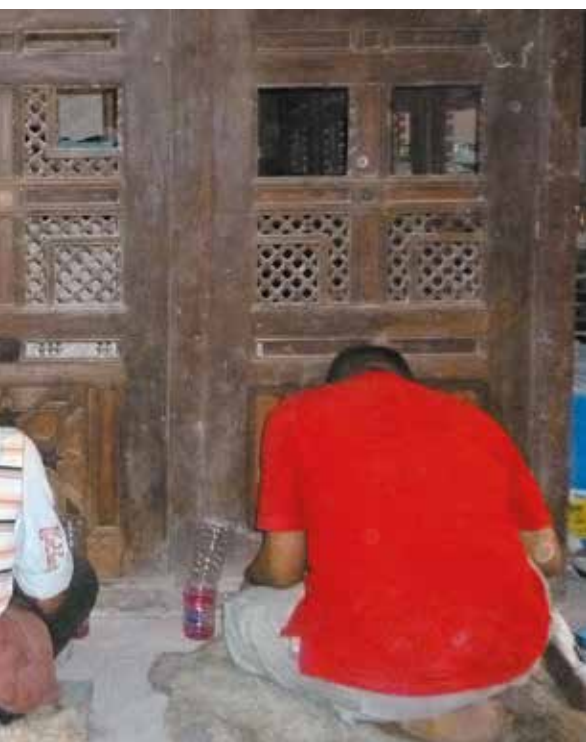
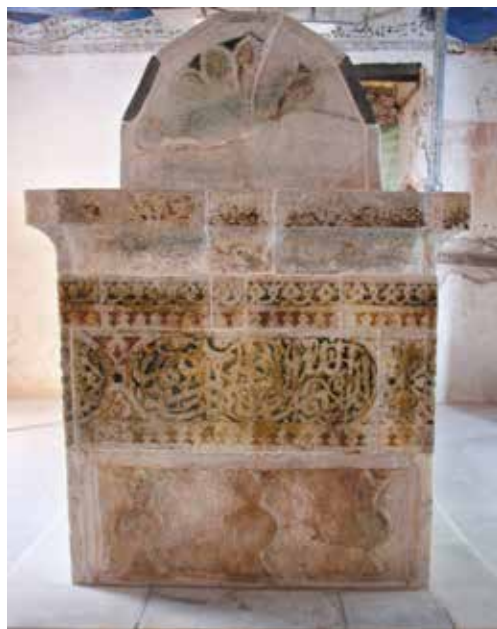
The Cenotaph of al-Ashraf II after the intervention and the wooden panels of Mashrabiyyas (left); he Cenotaph of Al Nasir Ahmad (under)

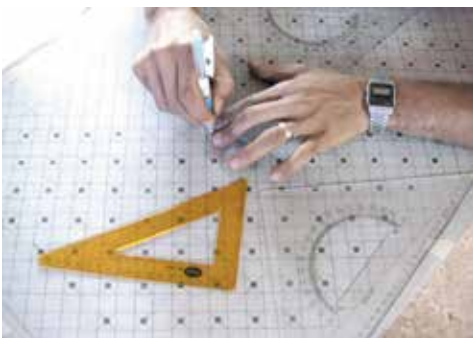
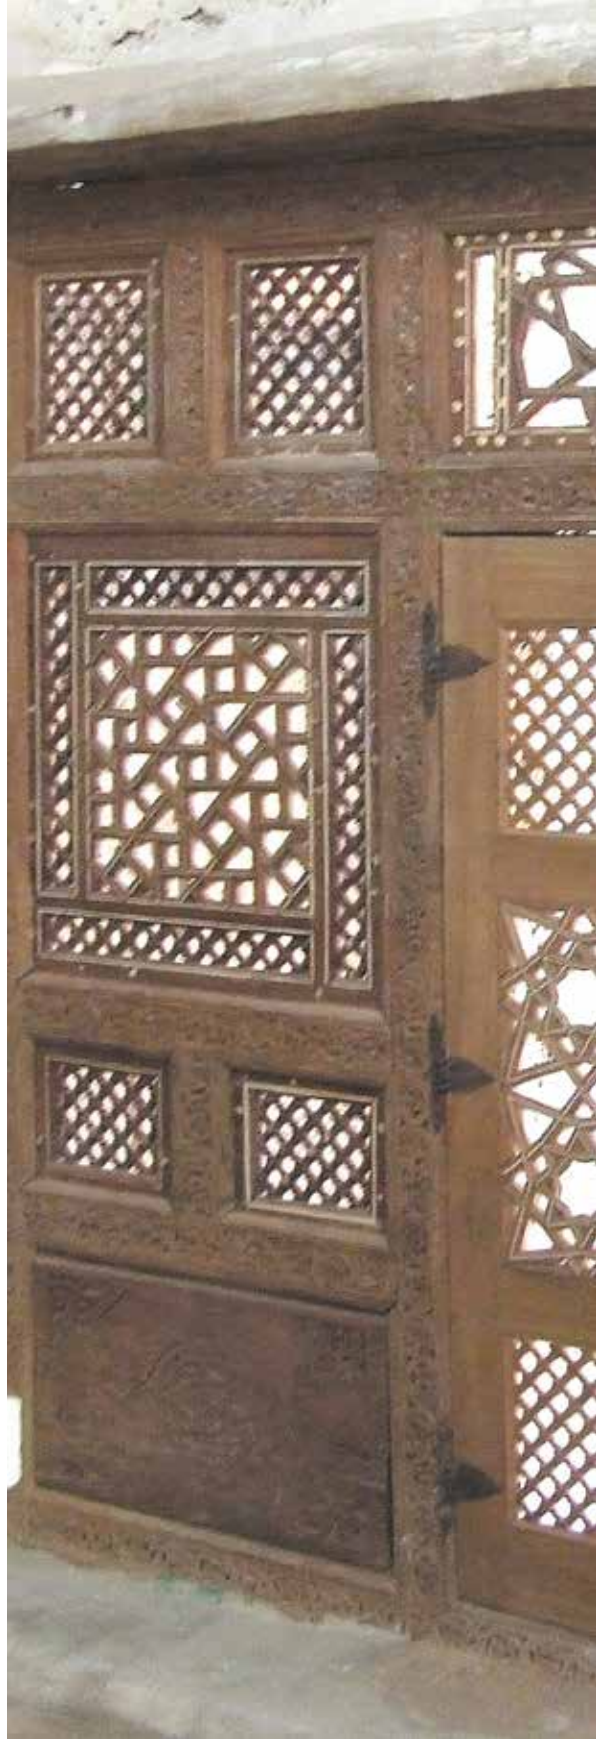
Mashrabiya panel after the intervention, view from the inside

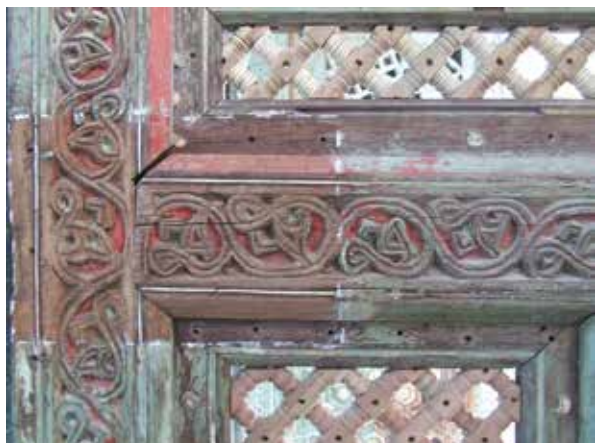
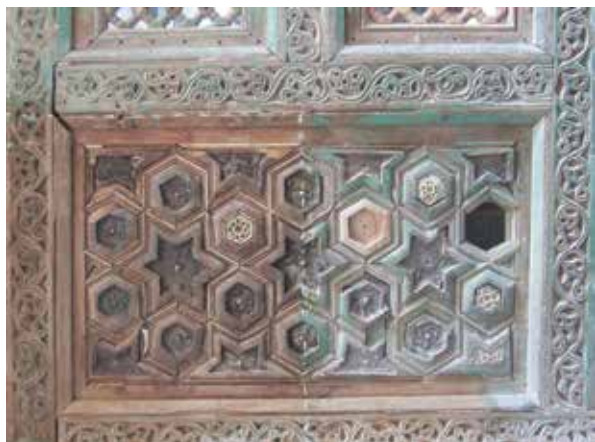
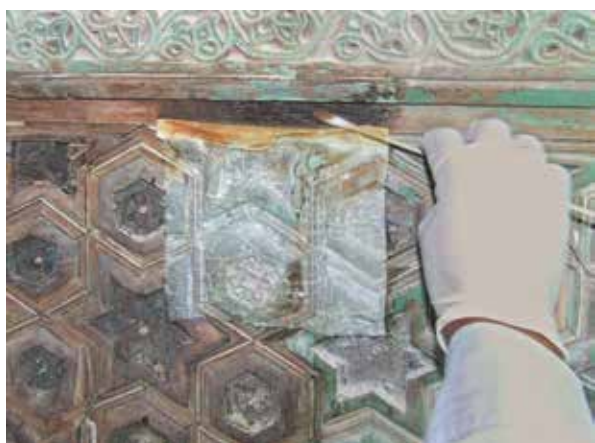
Mashrabiya panel after the intervention, view from the courtyard (above); cleaning tiles (left)

The use of different methodologies, gave satisfactory results. The large panel partitions, where the wooden surface needed to be exposed and its natural coat had to be preserved, were treated with the scalpel and a softening mixture applied with cotton and brush.

The carved and painted frames were treated by interposing a veil of Japanese paper in order to totally preserve the ancient original pigments.

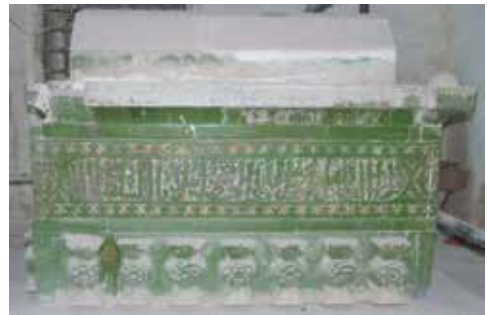
The Cenotaph of al-Ashraf II before the intervention

The cenotaph of al-Ashraf II, who died in 1400/803 HJ, consists of a rectangular parallel-piped carved marble that are divided into two main orders: the lower, the podium, has a series of bas-reliefs representing the Rasulid coat of arms, the second has an inscription in middle-relief. On the four sides an engraved Quranic inscription runs along the upper edge. The marble plates are anchored to an inner supporting structure, made of bricks that have been whitewashed with *qadad*, and reinforced by iron bands to which they are attached. The top of the cenotaph is covered by white plates, of a semi-hexagonal shape, with carved inscriptions, that unfortunately are much eroded. On both sides of the top there are polychrome ornaments, while the side elevations are decorated with an inscription in relief, originally gilded on a blue background.

During the seventies of the twentieth century the cenotaph had been painted with an oily green varnish that hid the precious decorations and the top plates had been ruined along with the crowning frame. It was evident that several pieces were disas-

sembled and reassembled badly; some parts of the parallel-piped and the edges had stability problems: the internal decay caused the delamination of the mortar between the bricks and the swelling of the reinforcement bars.

At the end of the first step, the removal of the more adhesive black layer still remained. Elimination of the adhesive layer required a different system which would not damage the gold leaf underneath. At the end of the first step, the removal of the more adhesive black layer still remained. Elimination of the adhesive layer required a different system which would not damage the gold leaf underneath.

This step was very difficult and long and was carried out using a chelate solution with a neutral pH. The result was very satisfactory as cleaning both the bare marble and the gilded arabesques proved to be delicate. Then the interventions involving the integration of the missing elements were initiated.

Starting from the upper edge and between the joints of the different marbles, fillings were realized by trying to get a neutral shade that

could complement the tone of the lighter marble, while around the gray and golden parts, it was opted to use a lower hue through glazing the color.

The final work involved the grazed and incomplete surfaces with the gold leaf, on which the retouching was carried out in order to rebalance the level of the orange color scheme used in the preparation of gold leaf.
